Relocation of net-acid-generating waste to improve post-mining water chemistry

Kevin A. Morin *, Nora M. Hutt

Abstract

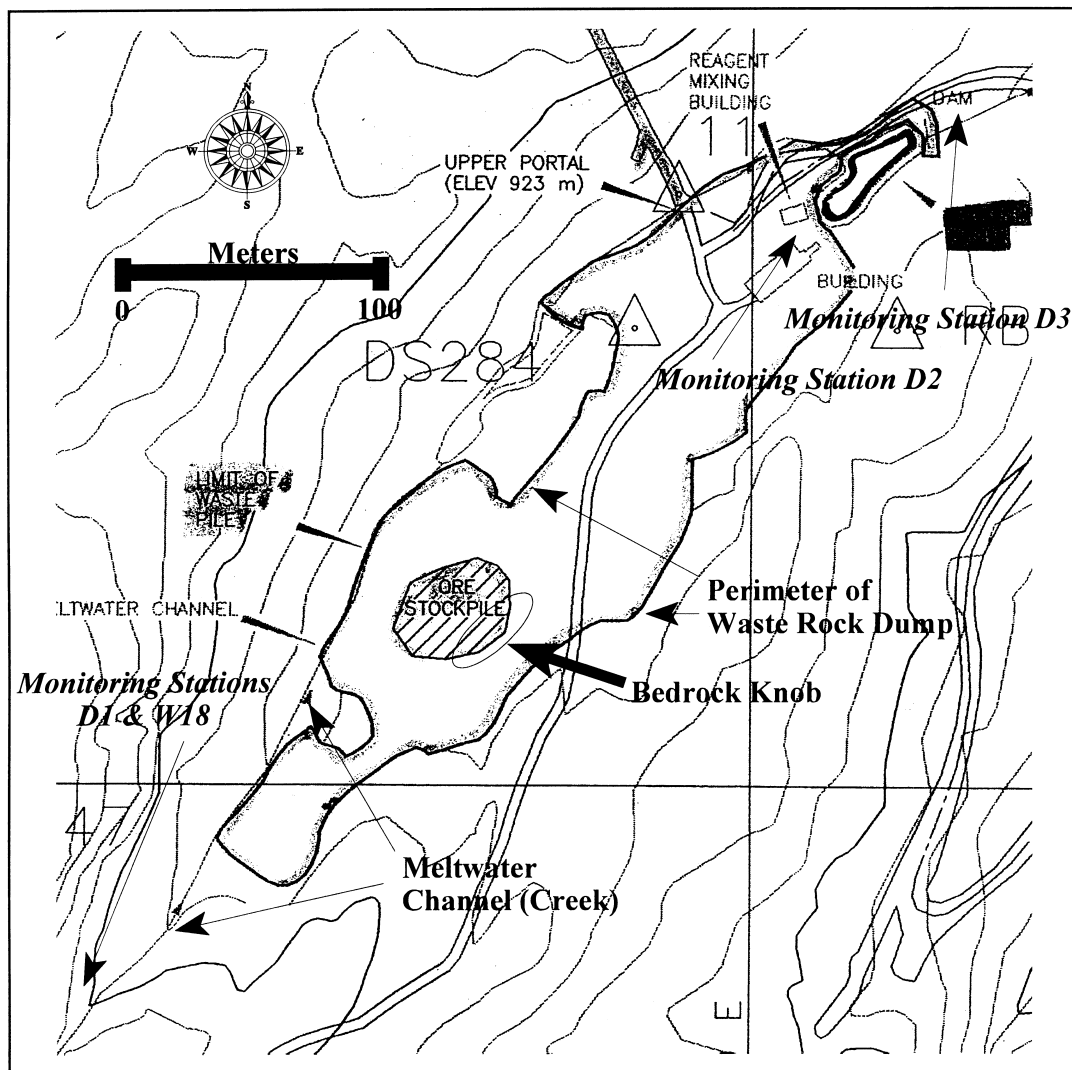
Fig. 1. Map of the Eskay Creek waste-rock dump (from prime resources files); contour interval 10 m.

During mine development and the initial phase of mining in the early 1990s, approximately 100,000 t (1×10^5 t) of waste rock was placed in a narrow, shallow valley near the upper portal (Fig. 1). Within a few years, metal-laden acidic drainage began flowing from the dump, and active treatment with NaOH and lime was initiated. By 1994, long-term environmental liabilities and economics indicated that relocation and submergence were likely to be less expensive than long-term treatment. As a result, the mine carried out the relocation in 1994 and 1995, using 10-t trucks and placing the rock underwater in a nearby alpine lake. This lake is located at the top of a watershed with no fish and little biological activity. As a result, no major

The Eskay Creek waste-rock dump is a Type 2 dump as defined by Morin and Hutt [2]. These dumps reside in valleys and thus valley-wall runoff and basal creek flow are directed into and through the waste rock. The Eskay Creek waste-rock dump was built in the early 1990s, and is elongated in the northeast–southwest direction (Fig. 1). The areal extent of the dump is approximately 350 m by an average of 80 m. The approximate elevation of the north-eastern half was roughly 923 m (same as the upper portal), whereas the southwestern half was several meters higher,

Eventually waste rock was dumped outside the dacite-pad perimeter due to unanticipated volumes. In particular, some waste rock was placed adjacent to the intermittent stream or “meltwater channel” (Fig. 1) along the northwest side of the valley. This stream, with flows up to 8000 l/min, then occasionally flowed into and through the waste rock, aiding the flushing and transport of acidity and metals.

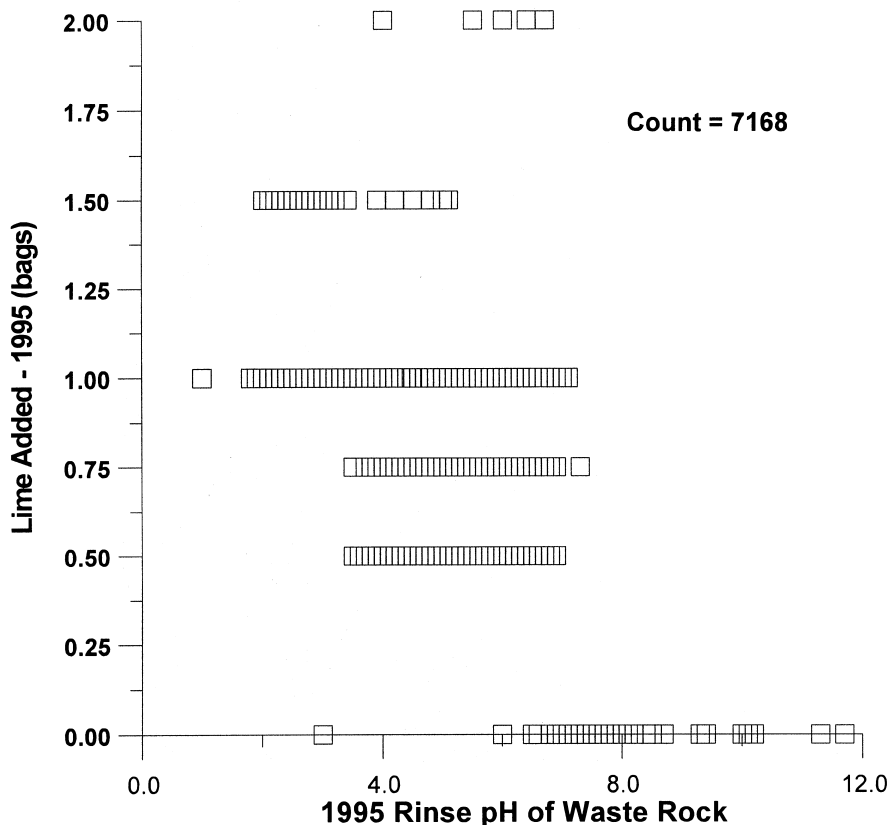
Eskay Creek Waste Rock Dump

Lime Added vs 1995 Waste Rock Rinse pH

Fig. 2. Bags of lime added per truckload of waste rock based on rinse pH in 1995.

To suppress the rapid release of metals and acidity from submerged Eskay Creek rock, lime in 50-lb bags was added to every truck load as needed (Fig. 2), based on a laboratory-determined empirical relationship between rinse pH and required lime. To implement this, “rinse pHs” of excavated rock were measured dozens of times a day during relocation, by rinsing and soaking several kilograms of rock with distilled water in a large pail.

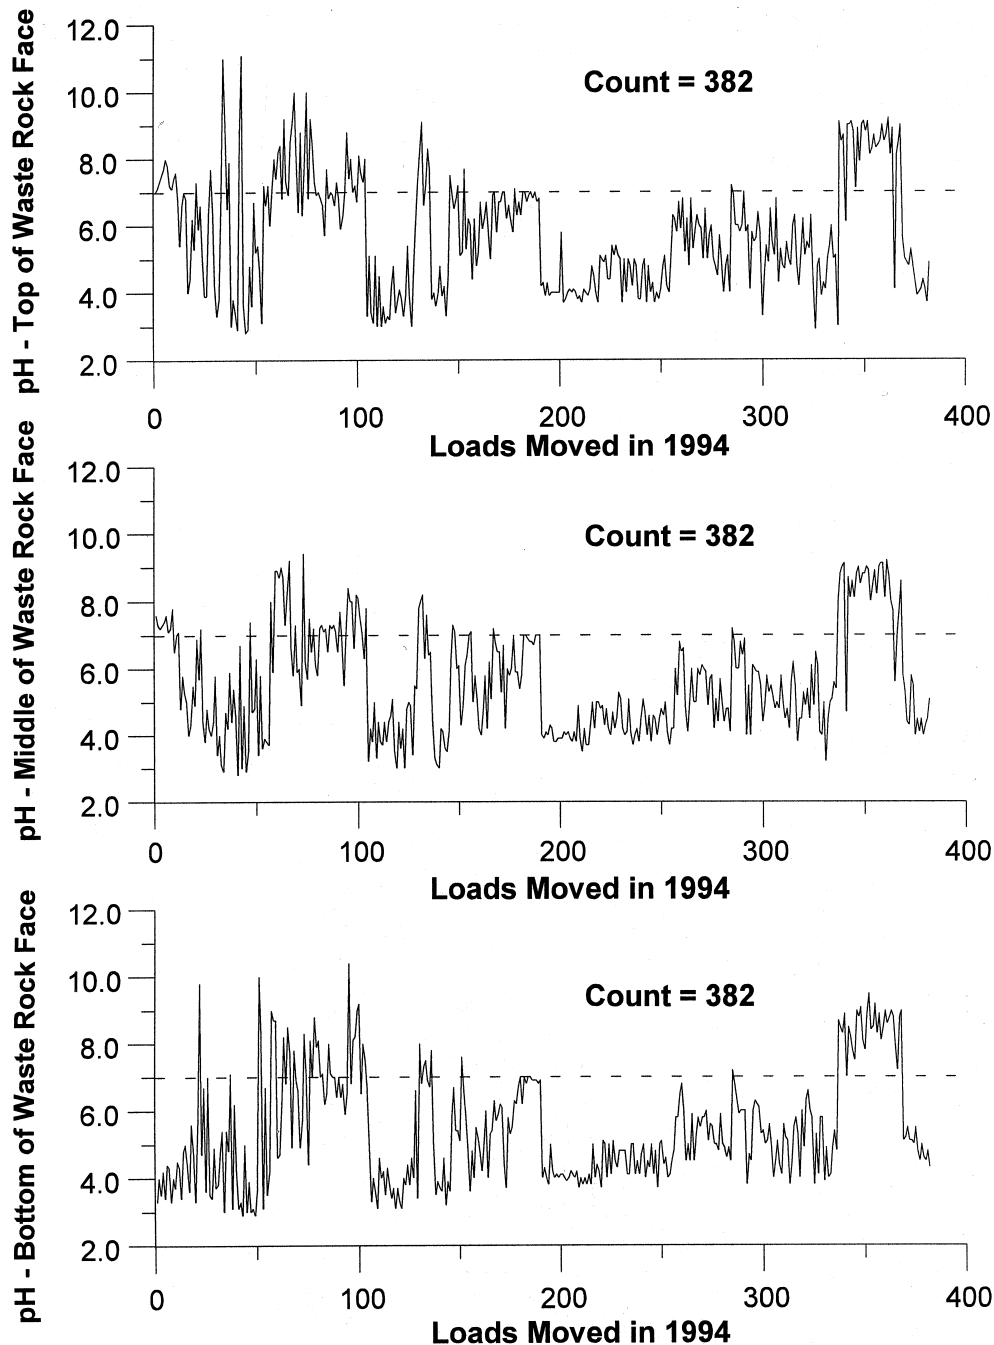
Fig. 3. Rinse pH from top, middle and bottom of waste-rock face in 1994.

In 1994, rinse pH was measured at the top, middle, and bottom of each newly exposed face of waste rock. In 1995, rinse pH was measured at the top, middle, and bottom of each excavated pile of rock, but only the average value of these three was recorded and used to determine appropriate lime addition. The locations at which these pH values were measured were not recorded, because they were not important to the relocation. Nevertheless, the temporal trends in the values reveal the frequency with which acidic and neutral rock were encountered during relocation (Figs. 3 and 4).

The 1994 data showed that similar, but not identical, trends in rinse pH were found at all three vertical locations on the waste-rock faces (Fig. 3; values above 10 probably reflect cross-contamination with lime). As a result, the severity of the retained acidity was generally constant throughout a vertical profile. However, significant fluctuations in pH were encountered almost on a daily basis in the horizontal plane, but occasional

The conclusion from most of the PF sites was that (1) the rate of water movement vertically into most of the waste rock dump was minimal due to the silt cap and could not be measured with the technique and (2) the dump retained a large amount of acidity due to the minimized infiltration, which was demonstrated by the rinse pHs during relocation (Figs. 3 and 4). This also confirmed the major role of the adjacent intermittent stream,

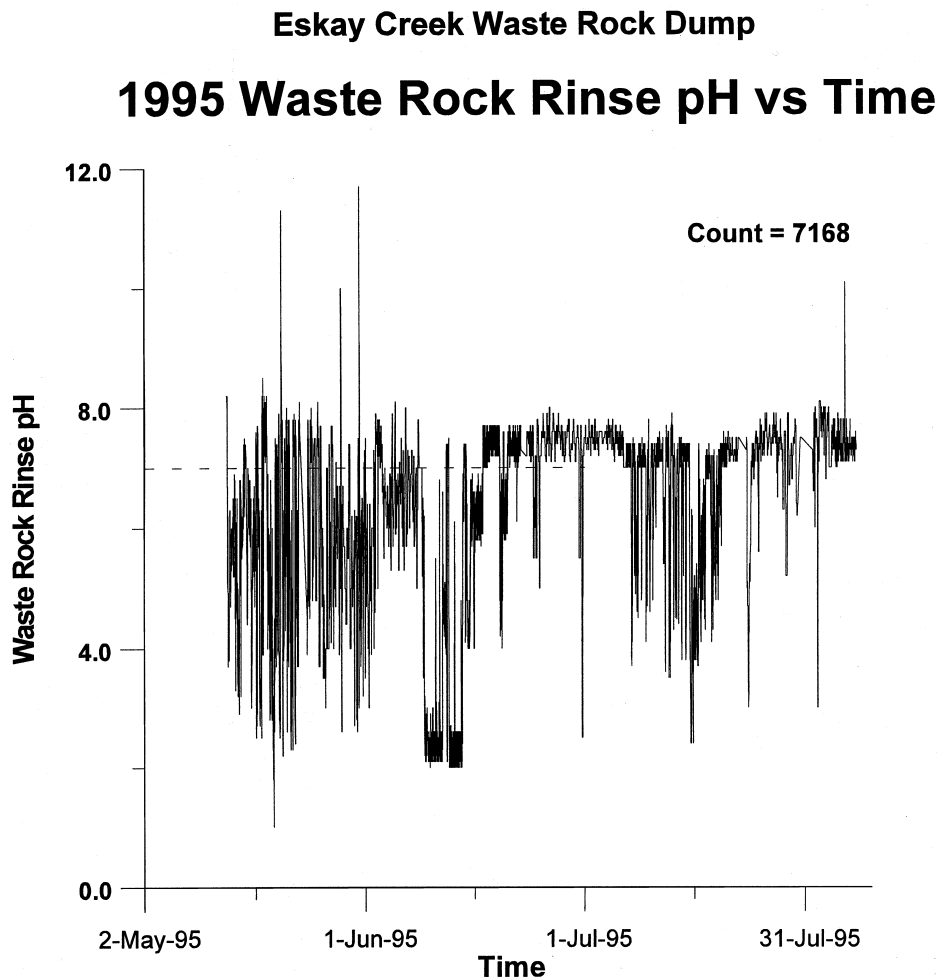
Fig. 4. Average rinse pH from excavated waste rock in 1995.

In 1995, the averaged vertical-profile values showed similar trends and behaviour as the 1994 data (Fig. 4). Consequently, there were again no extensive areas of acidic or neutral rock.
